ALUREPAIR EXAMPLE: FERRARI SIDE PANEL

ALUREPAIR EXAMPLE: Audi TT WHEEL ARCH

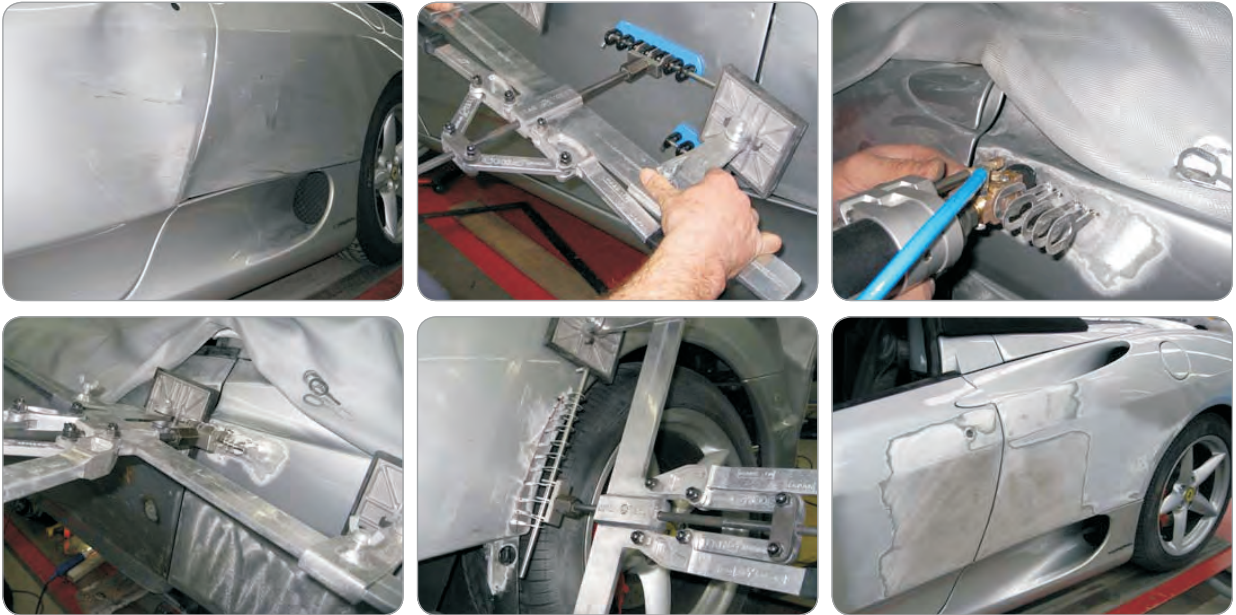
The repair of the side panel and door on this Ferrari 360 spider poses a real challenge for every panel repairer. Knowing the problems of panel part replacements, the car owner absolutely wanted to avoid the common exchange of door and side panel on this convertible car. The door alone has an extremely long delivery time and costs more than Rs 1,75,000. When the owner checked the car before the paint job, he was enthusiastic and was impressed with the high quality of the repair.

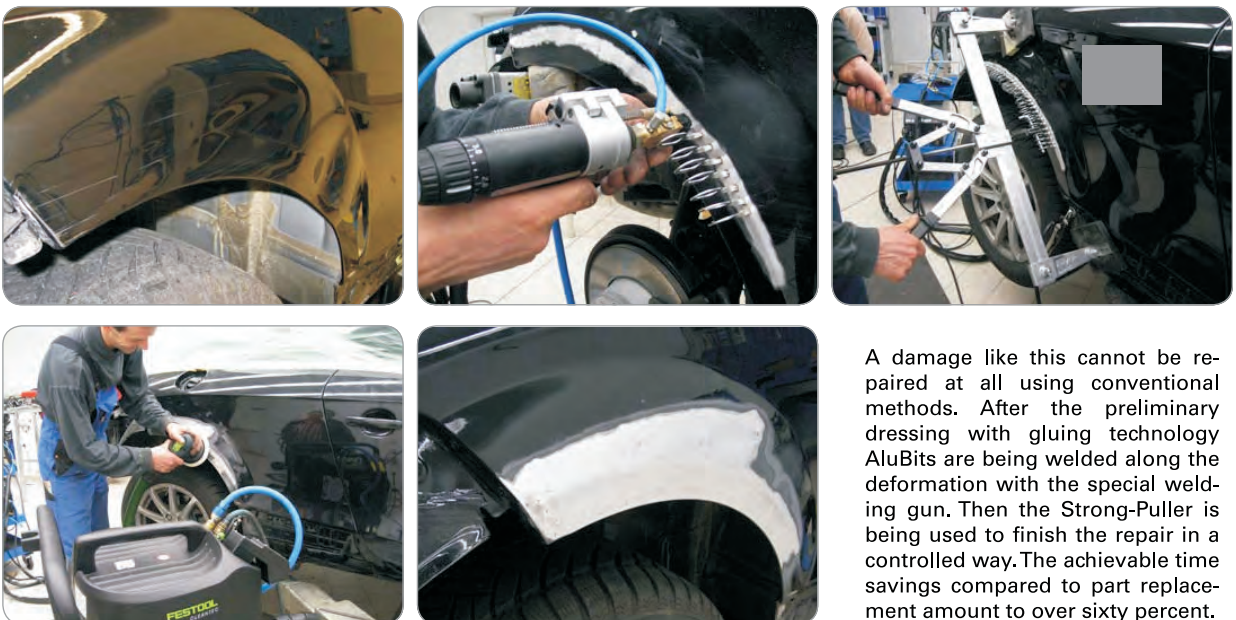
A damage like this cannot be repaired at all using conventional methods. After the preliminary dressing with gluing technology AluBits are being welded along the deformation with the special welding gun. Then the Strong-Puller is being used to finish the repair in a controlled way. The achievable time savings compared to part replacement amount to over sixty percent.
